# Manhole Inspection Summary

Manhole # S25GG1015MH

**Location** Address: **1118 WELDON AVE**

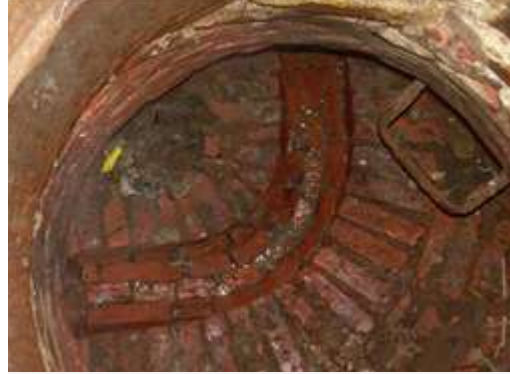
Top View

Corroded steps. Evidence of surcharge - Bench debris.

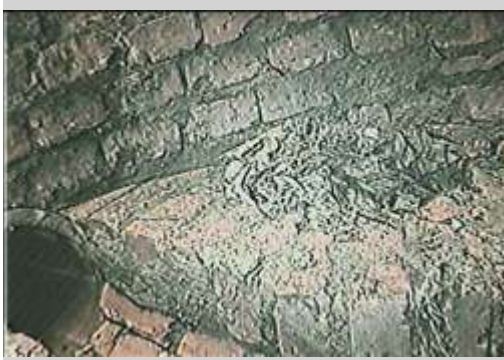
Defect

Barrel deterioration and infiltration.  
Channel deterioration. Bench debris.

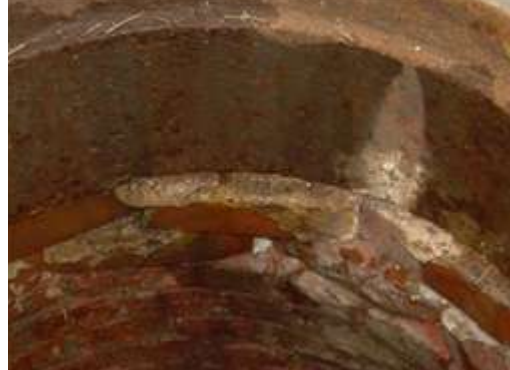
Defect

Frame leaks. Adjustment deterioration  
and infiltration.

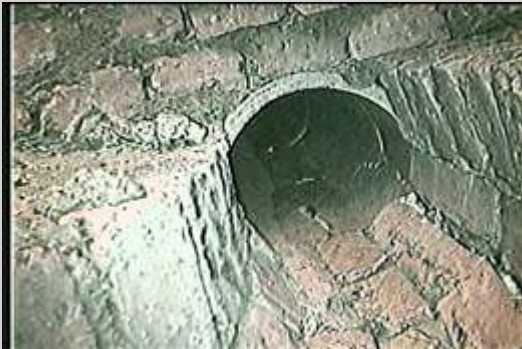
### 8 in. Circular Gravity Sewer Pipe Out @ 12 O'Clock

Barrel deterioration and infiltration. Channel deterioration.

Infiltration: **None** Pipe Seal Cond: **Cracked**

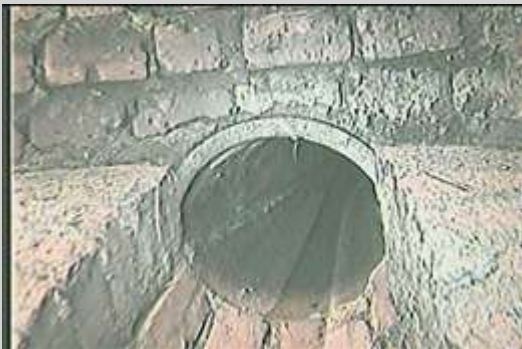
### 8 in. Circular Gravity Sewer Pipe In @ 9 O'Clock

Barrel and Channel deterioration.
